# Situation Photo Log

Saturday, September 29, 2012

Kalamazoo River / Enbridge Spill

Prepared by:  
Larry Rader  
START-USEPA  
Situation Unit Leader

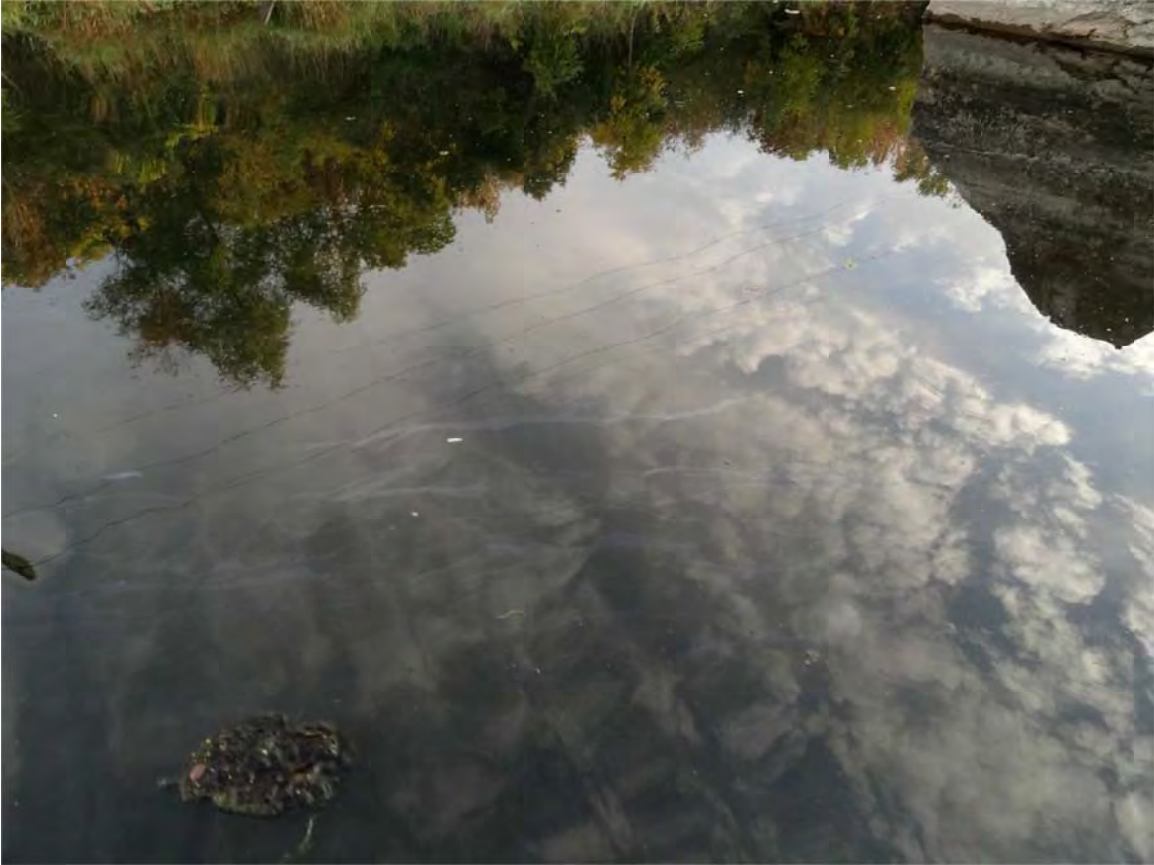
1. MP 5.63 RDB, spontaneous sheen ribbons observed along shoreline upstream of trestle.

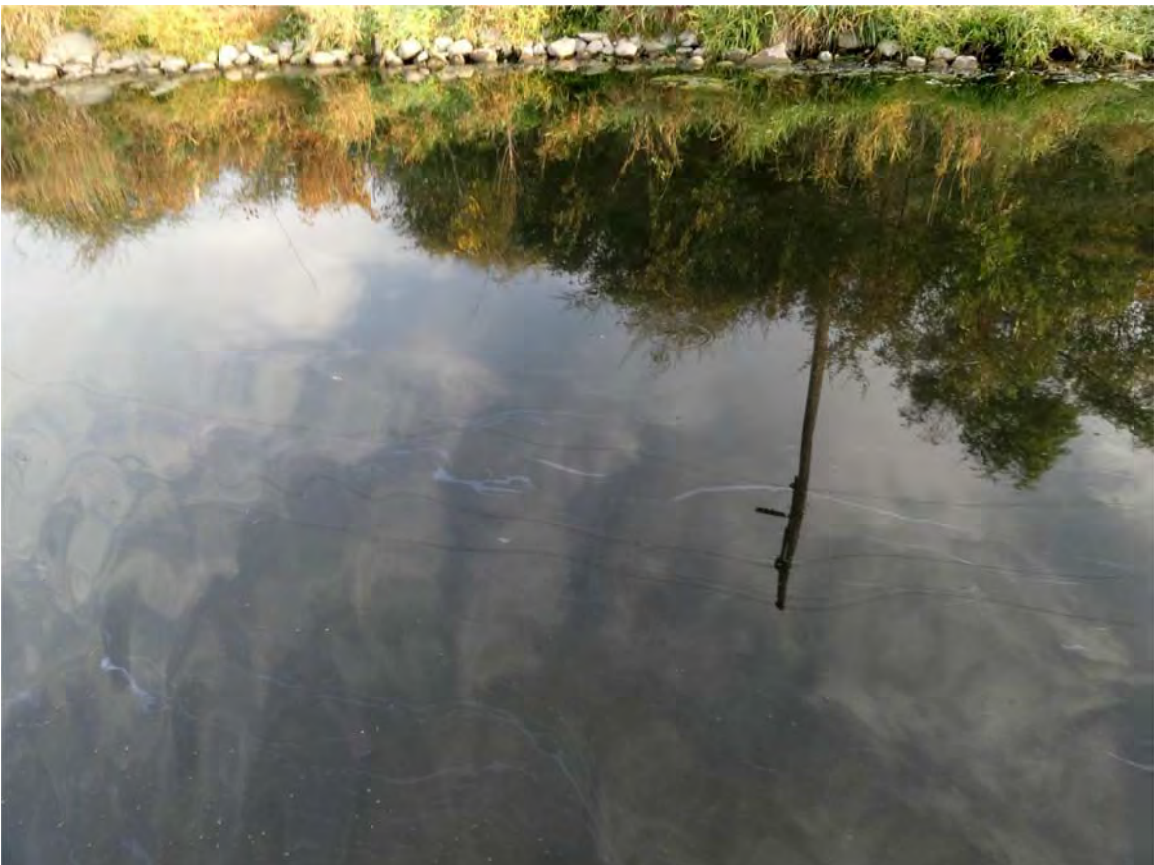
2. MP 5.63 RDB, spontaneous sheen observed upstream of trestle.

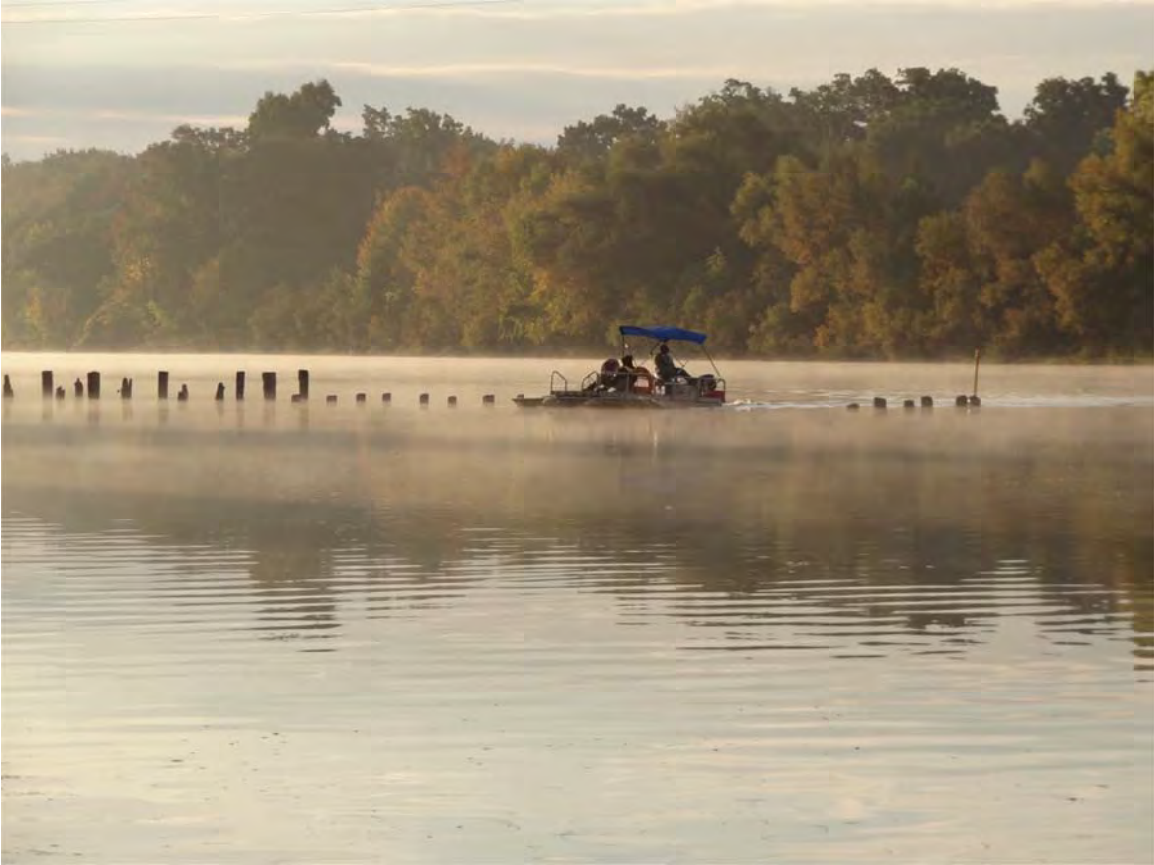
3. Sheen sweeper boat mobilizing to Ceresco Dam.

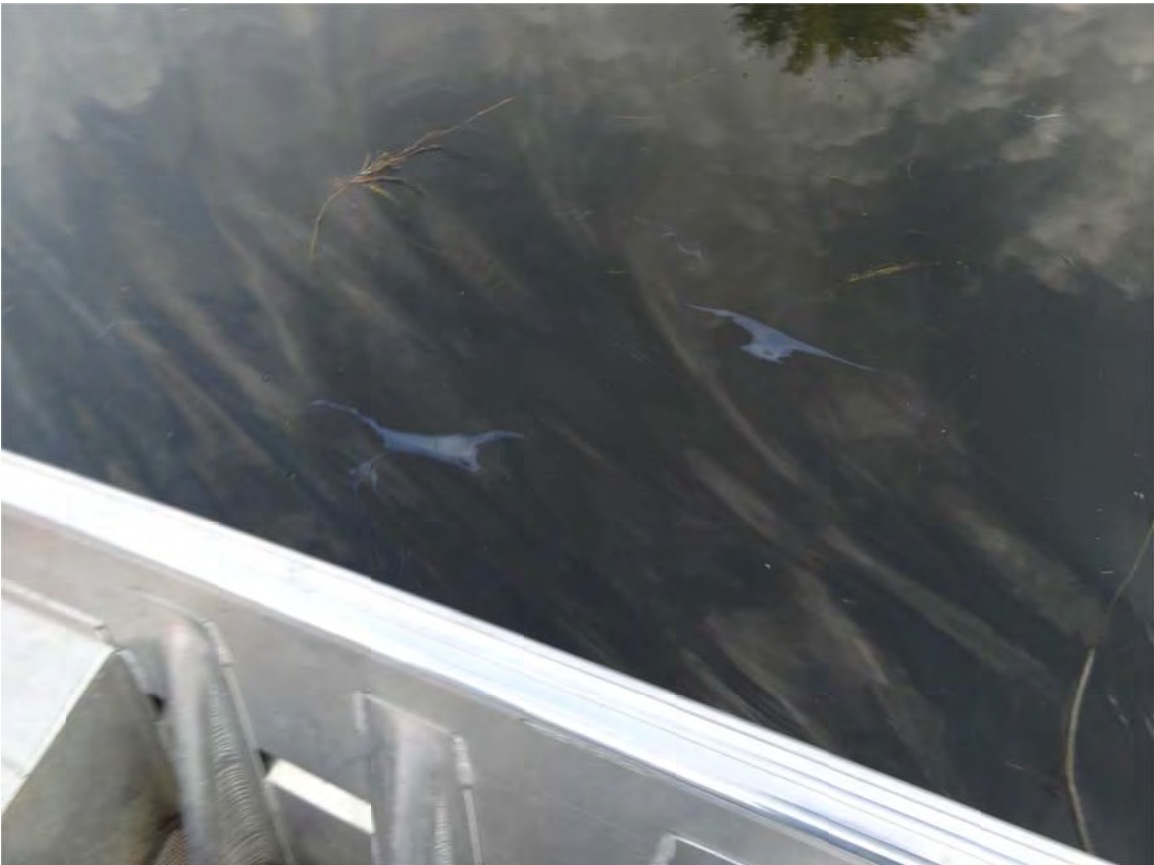
4. Sheen and tar globules observed within containment along Ceresco Dam control point.

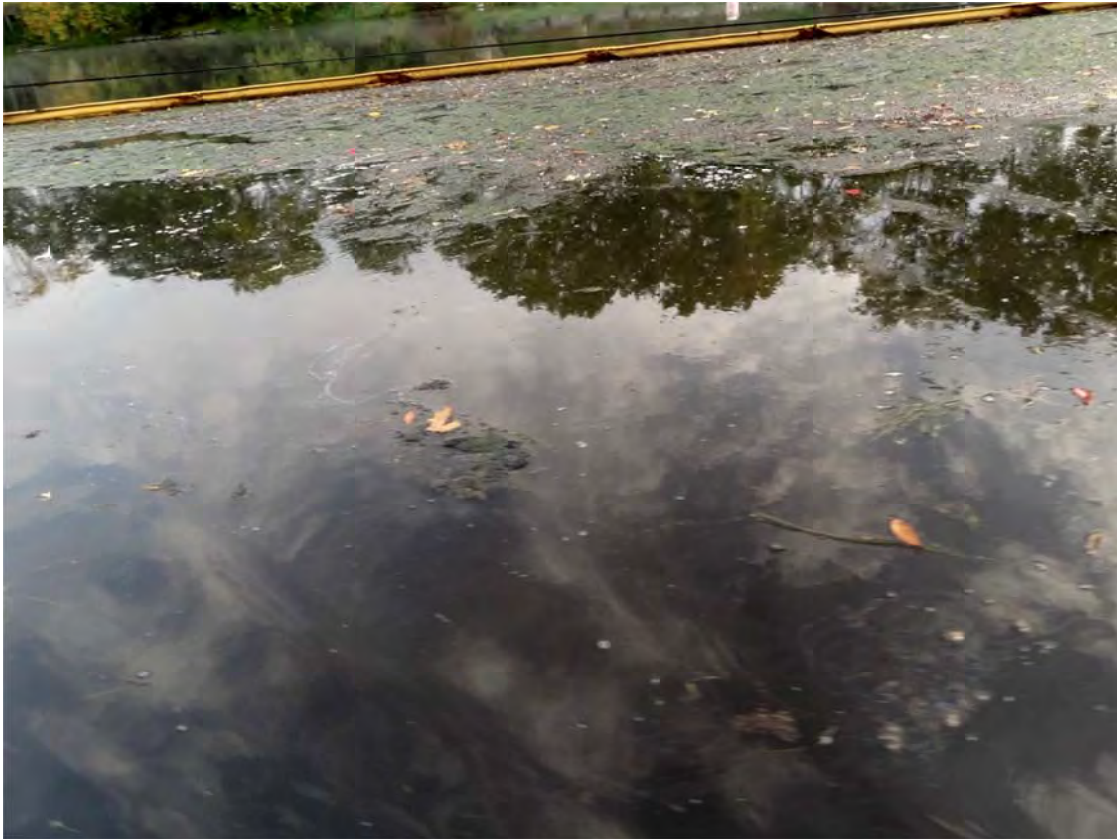
**5. Sheen and debris observed within containment along Ceresco Dam control point.**

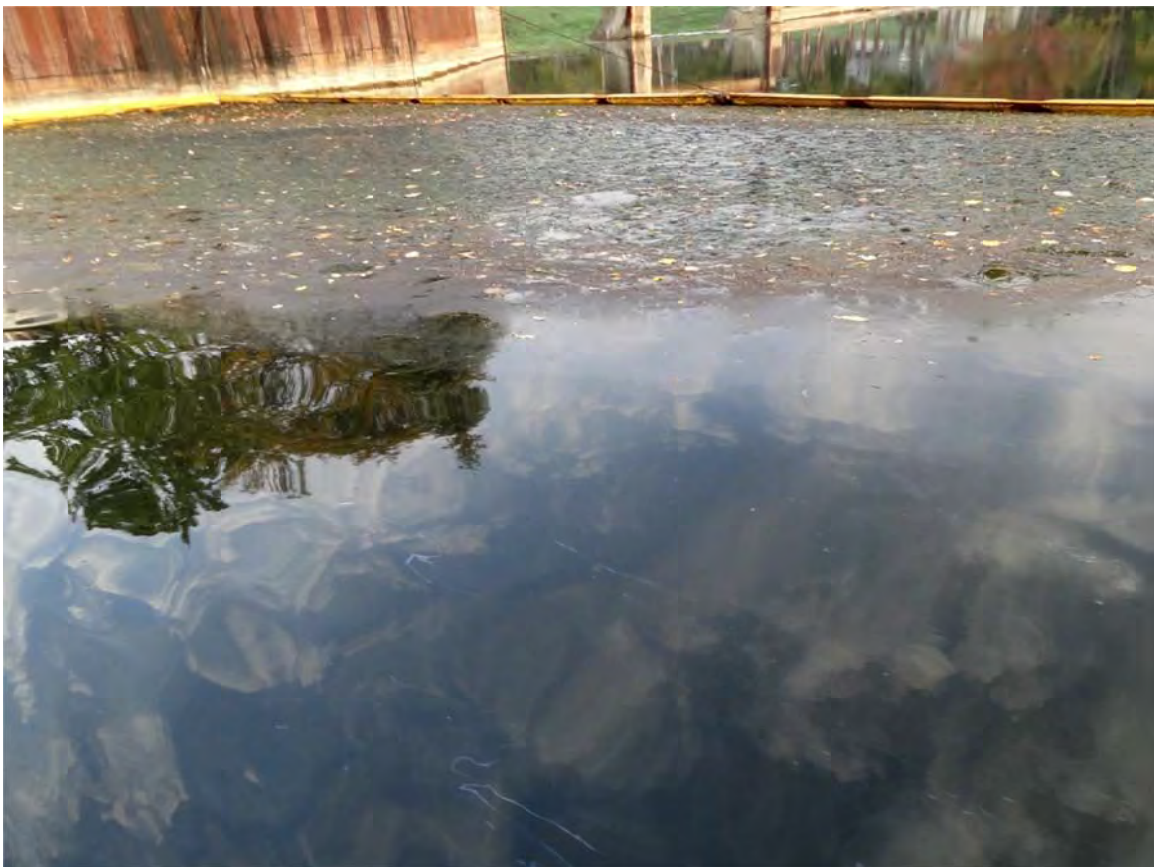
**6. Sheen and debris within containment at Ceresco Dam control point.**

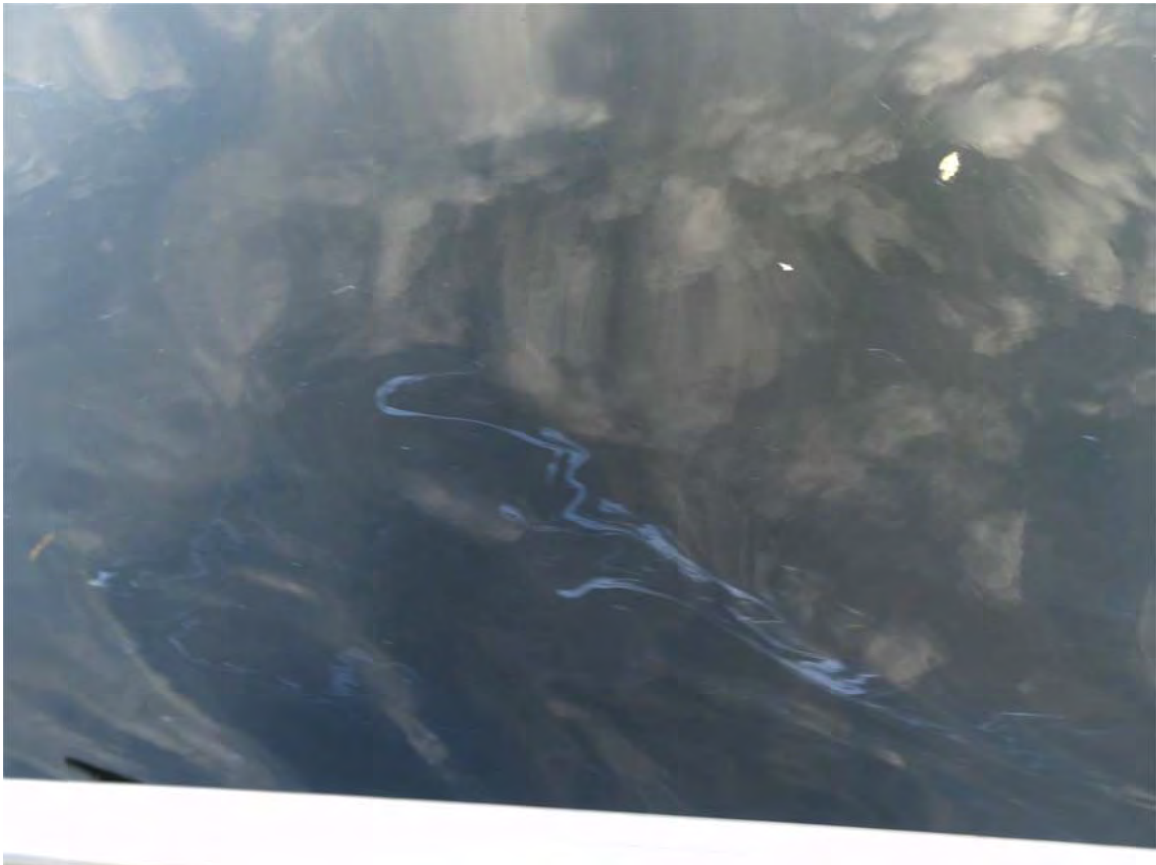
7. Sheen and tar globules along Ceresco Dam containment boom.

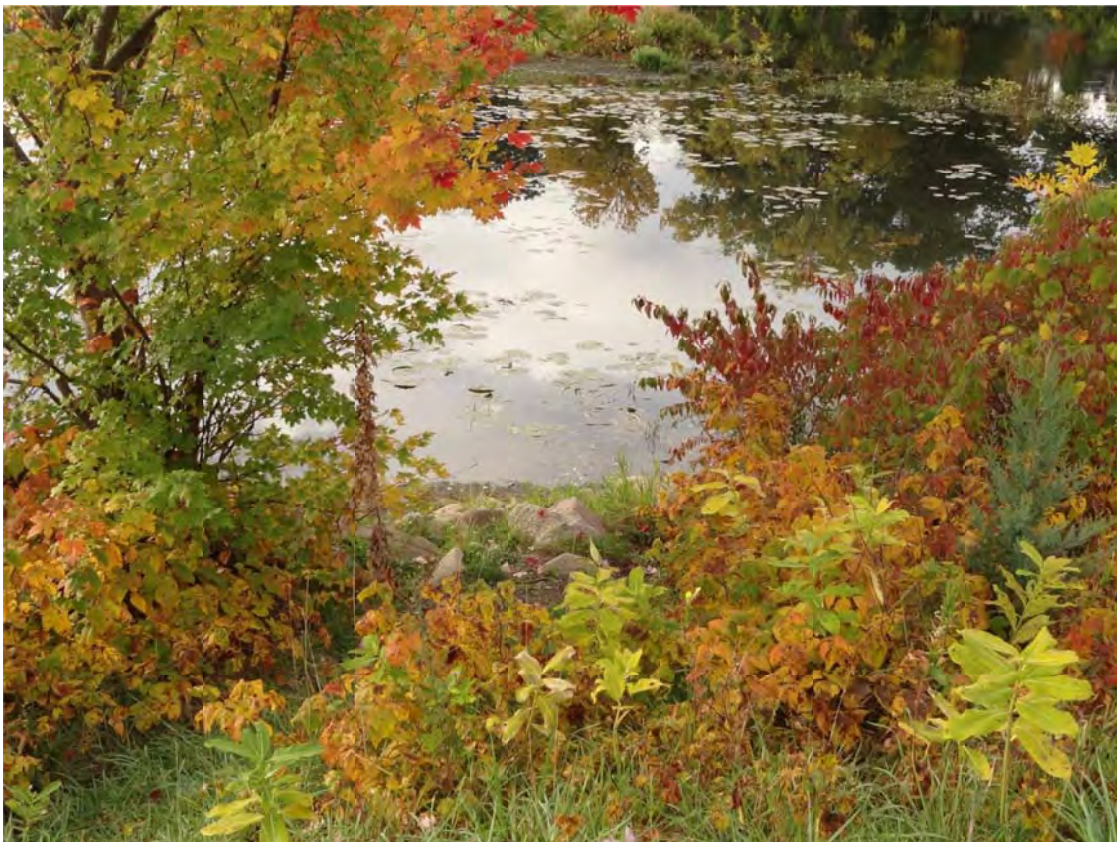
8. South Mill Pond east of main river channel. No sheen observed.

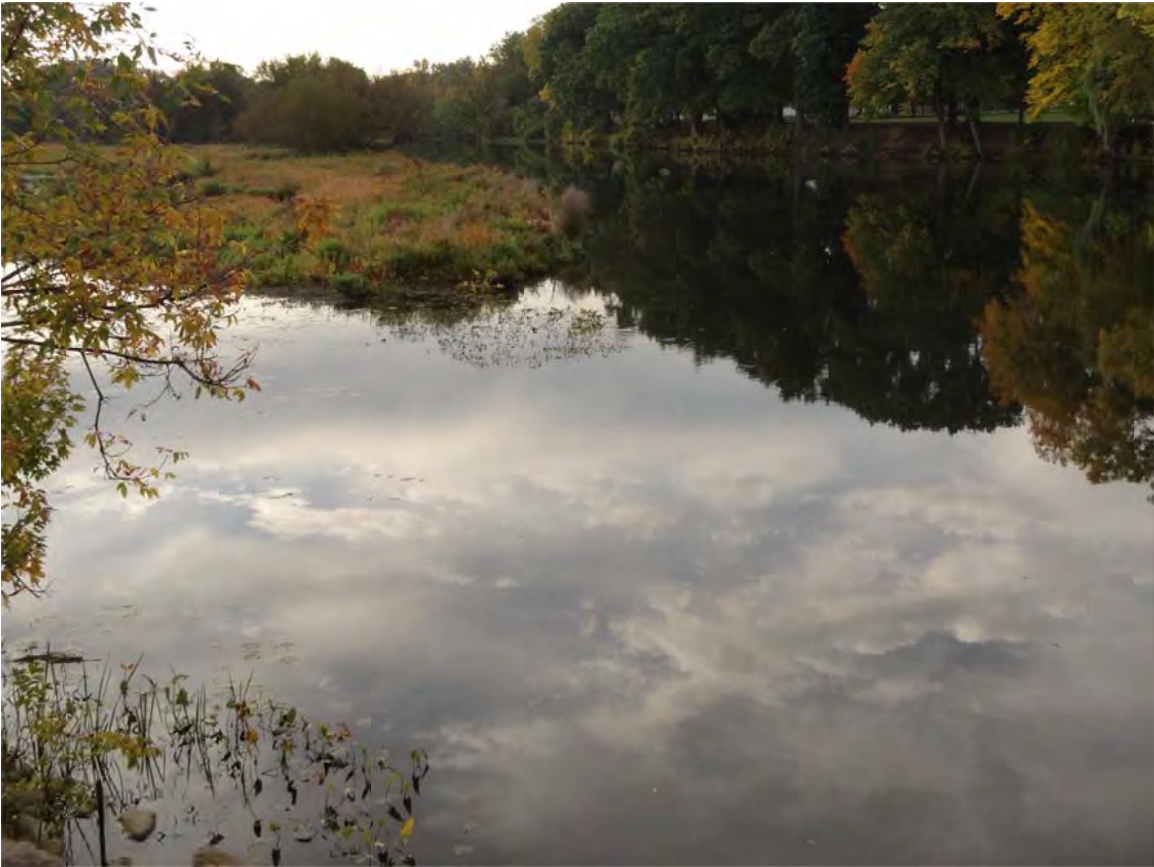
9. MP 15.5 South Mill Pond RDB of river channel, no sheen observed.

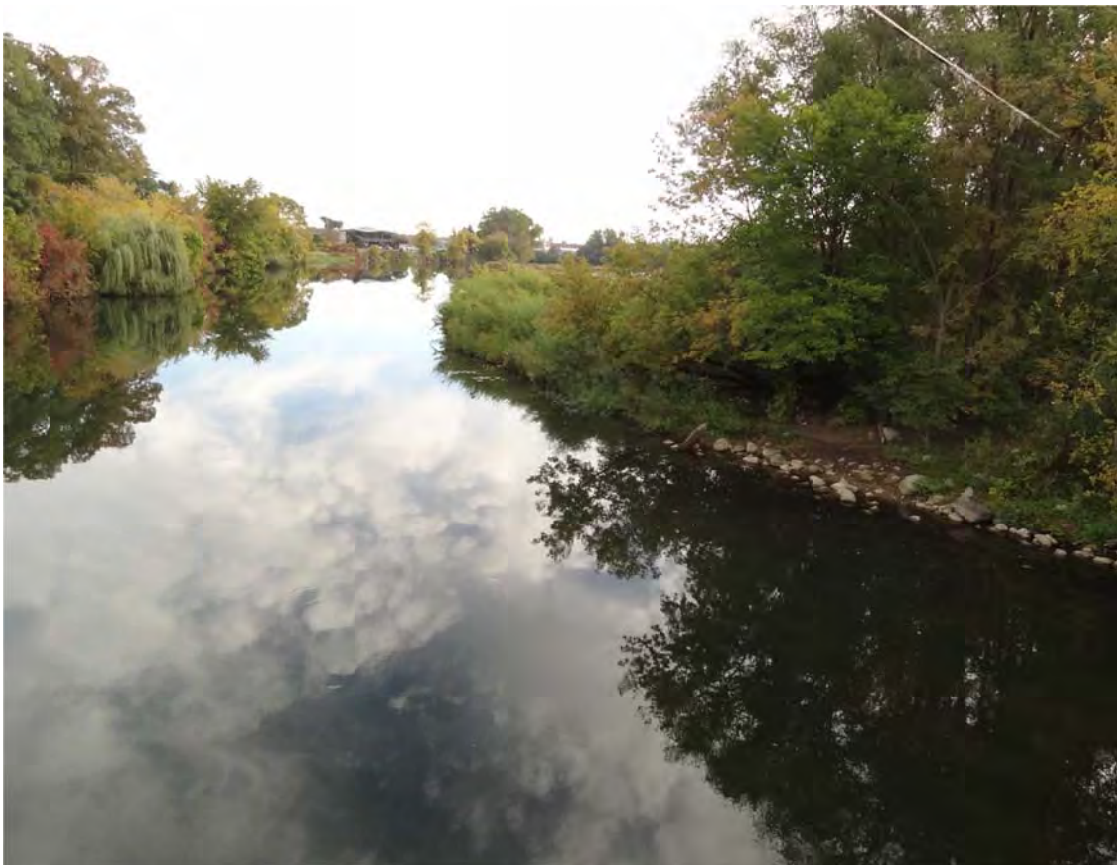
10. View of main river channel running to North Mill Pond. No sheen observed.

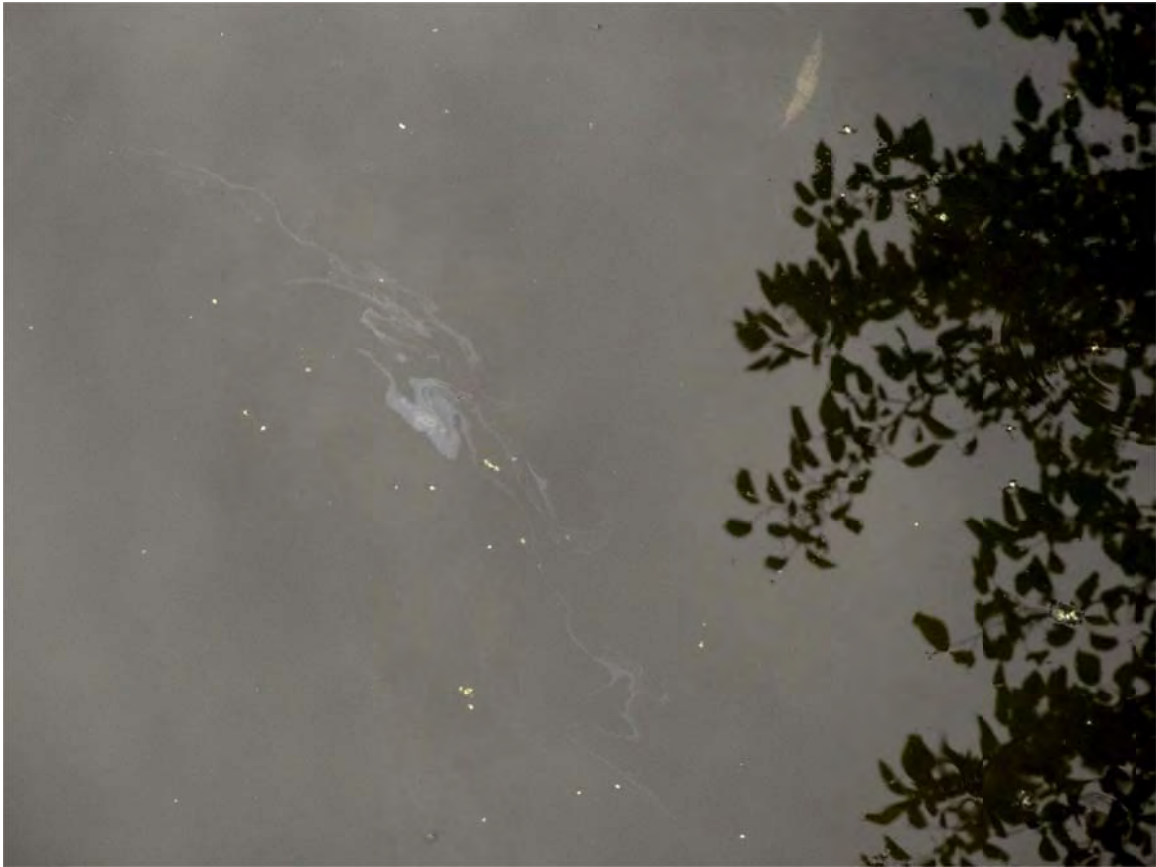
**11. Sheen ribbon and tar globule passing under Burnham Street Bridge at the Mill Ponds. Sheen quantity did not warrant a sheen response.**

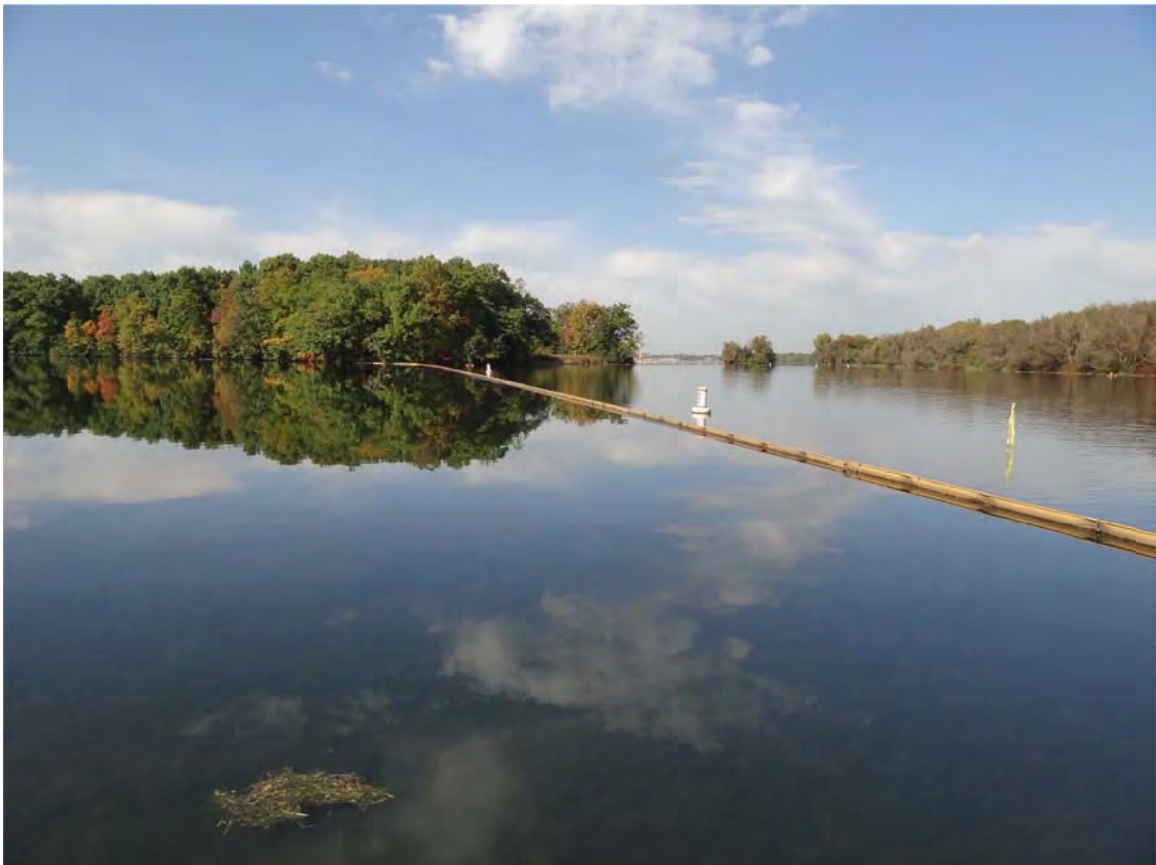
**12. Boom configuration C in Morrow Lake Delta. Sheen observed along containment boom.**

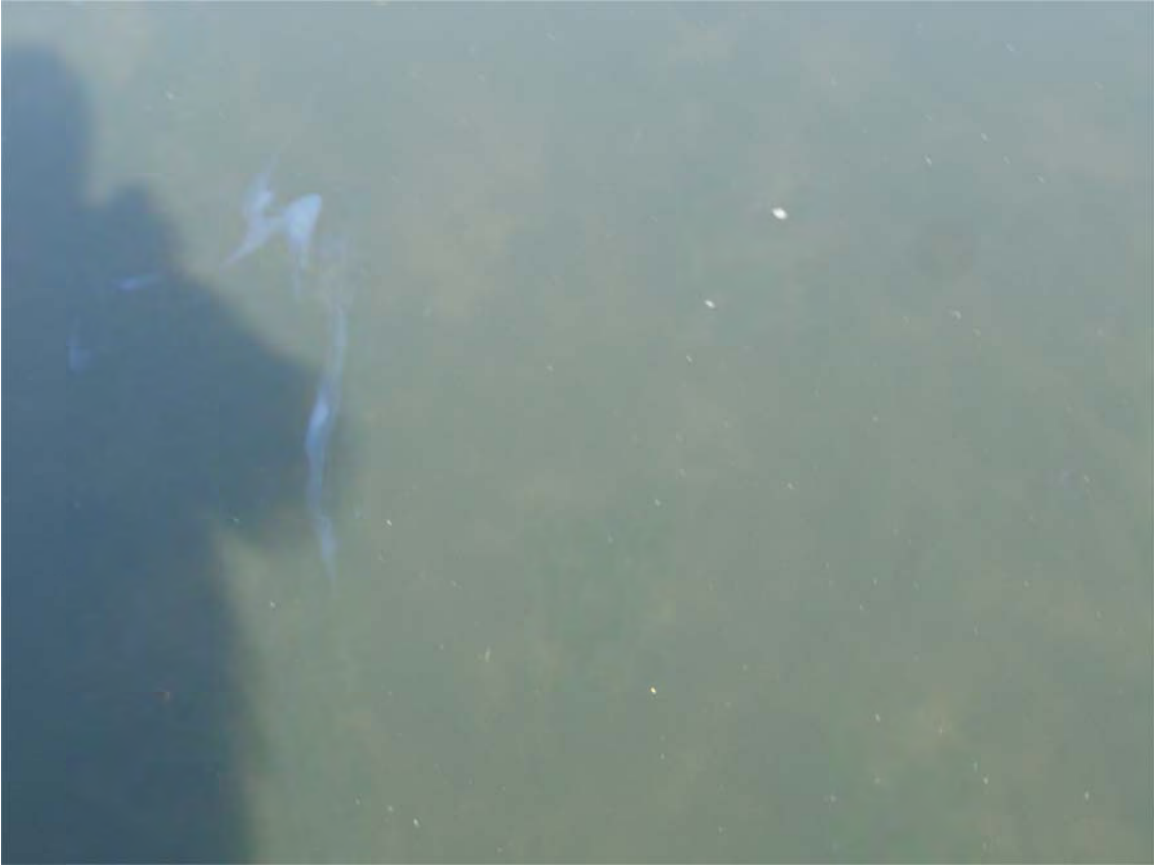
**13. Sheen and tar globules observed along boom C in Morrow Lake Delta.**

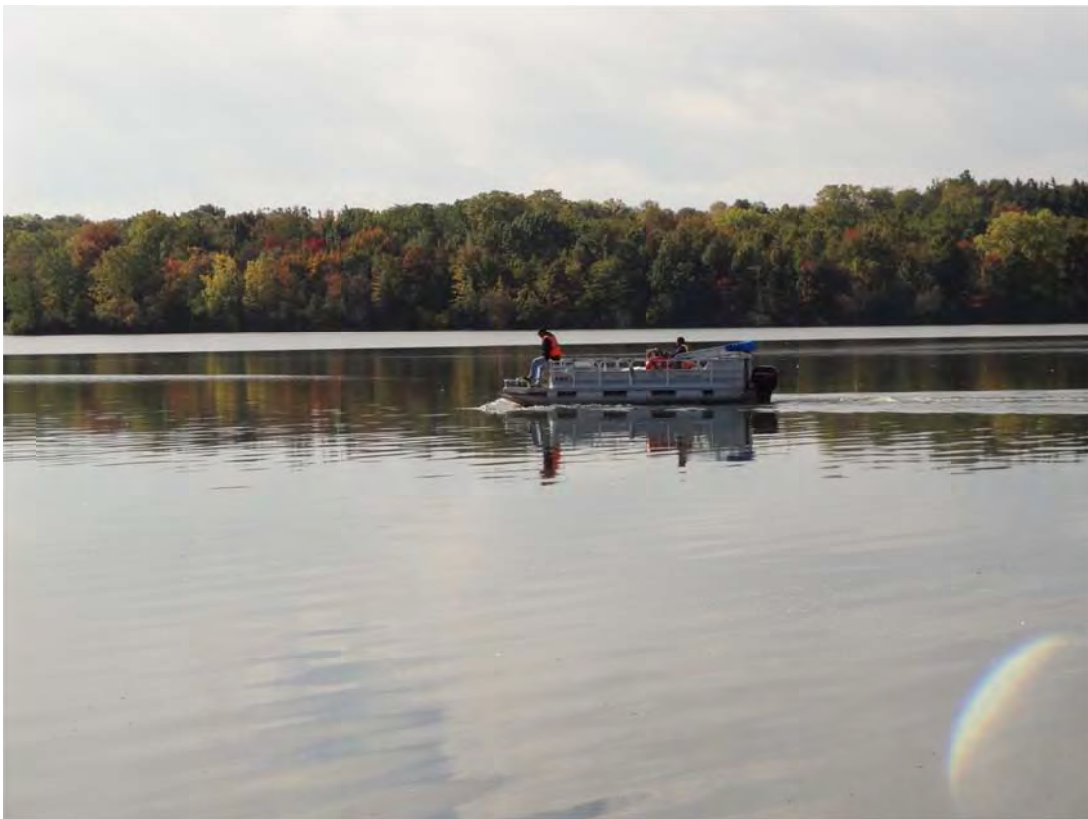
**14. Sheen sweeper boat operating in main river channel on Morrow Lake.**

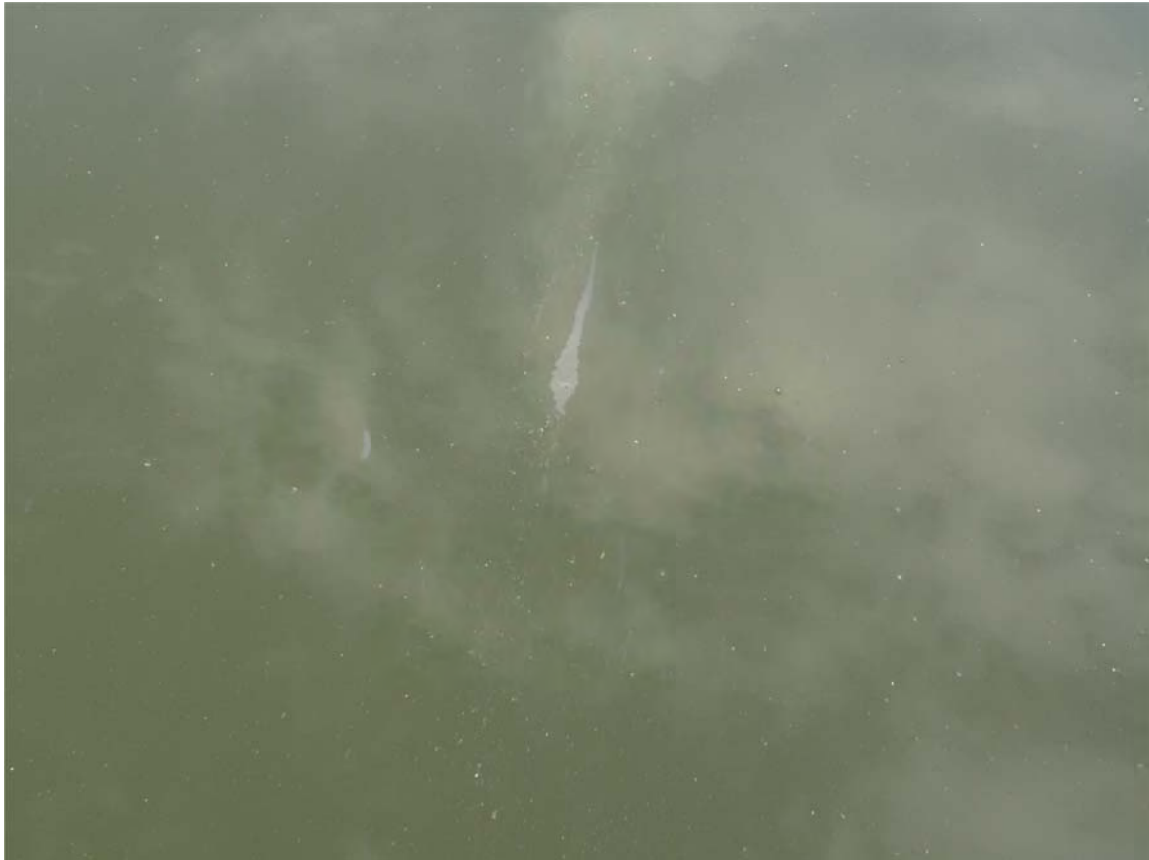
15. Sheen and tar globules observed in main river channel on Morrow Lake.

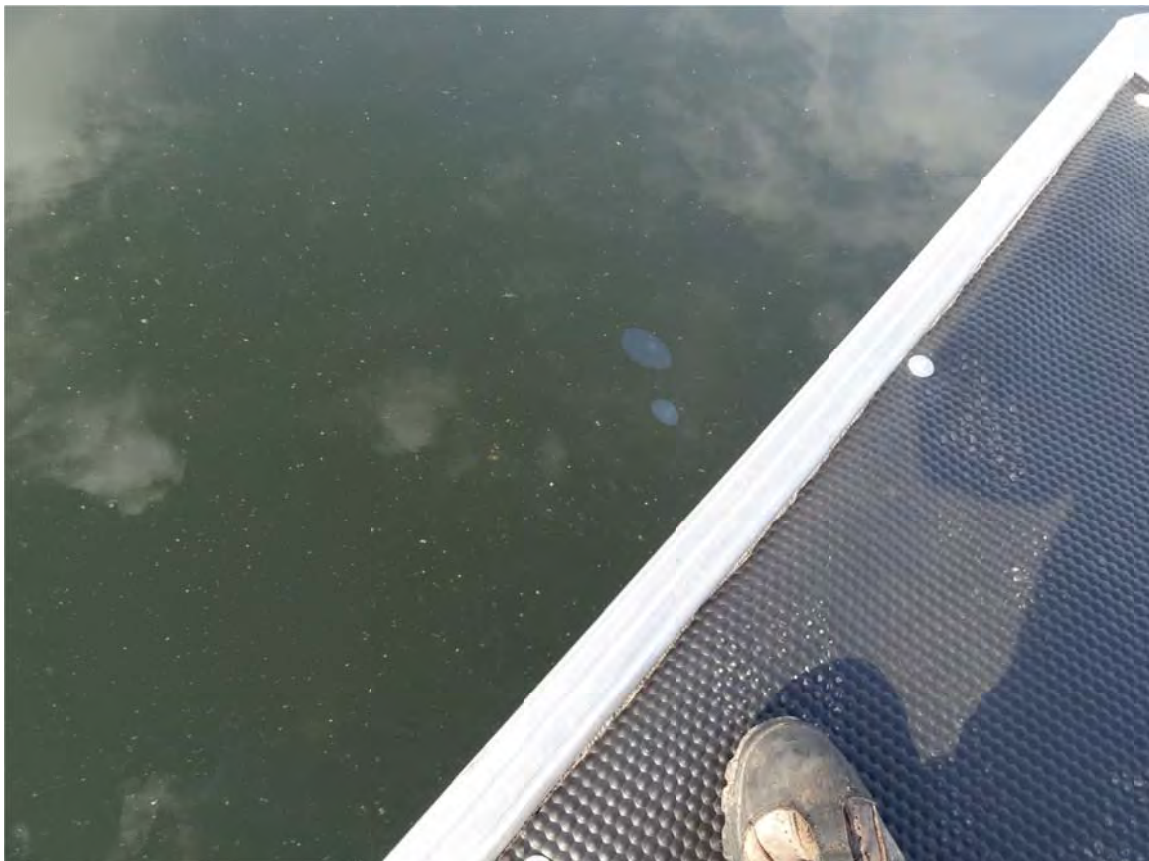
16. Sheen and tar globules observed in main river channel on Morrow Lake.

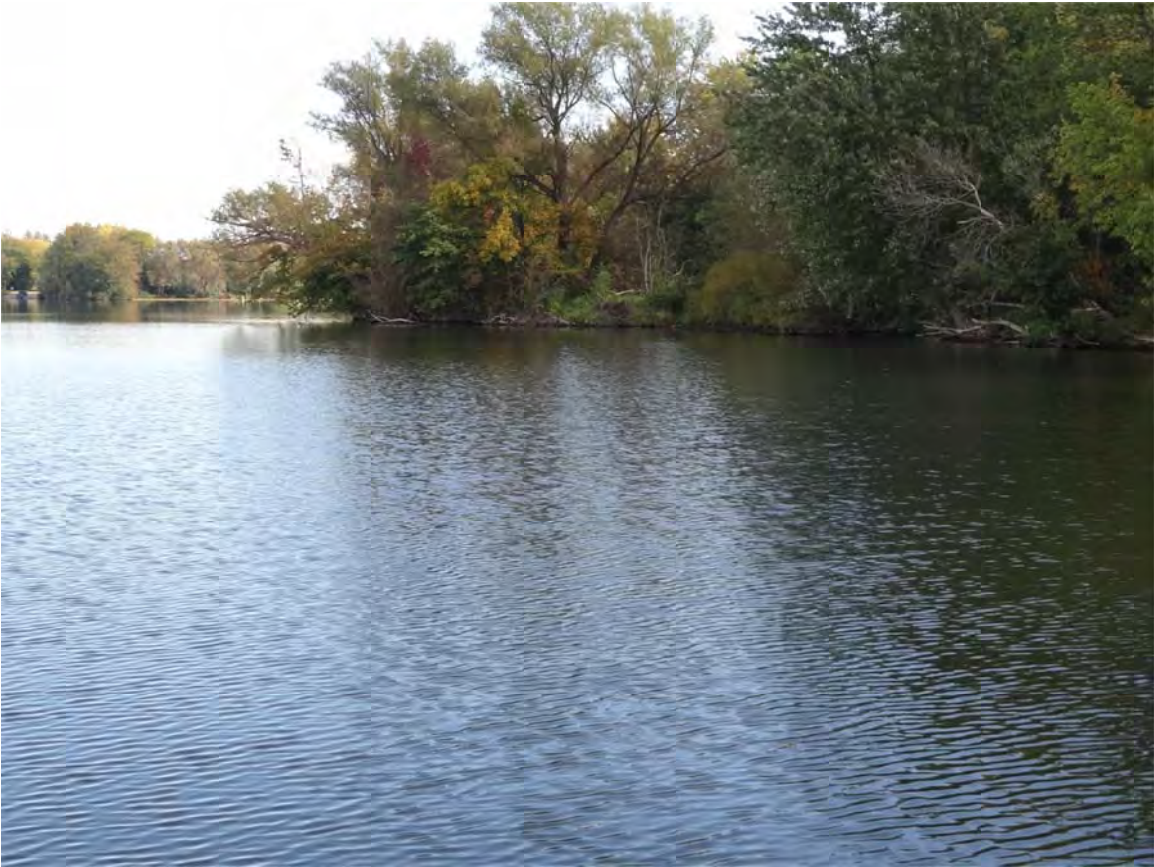
**17. South cove of Morrow Lake, no sheen or tar globules observed.**

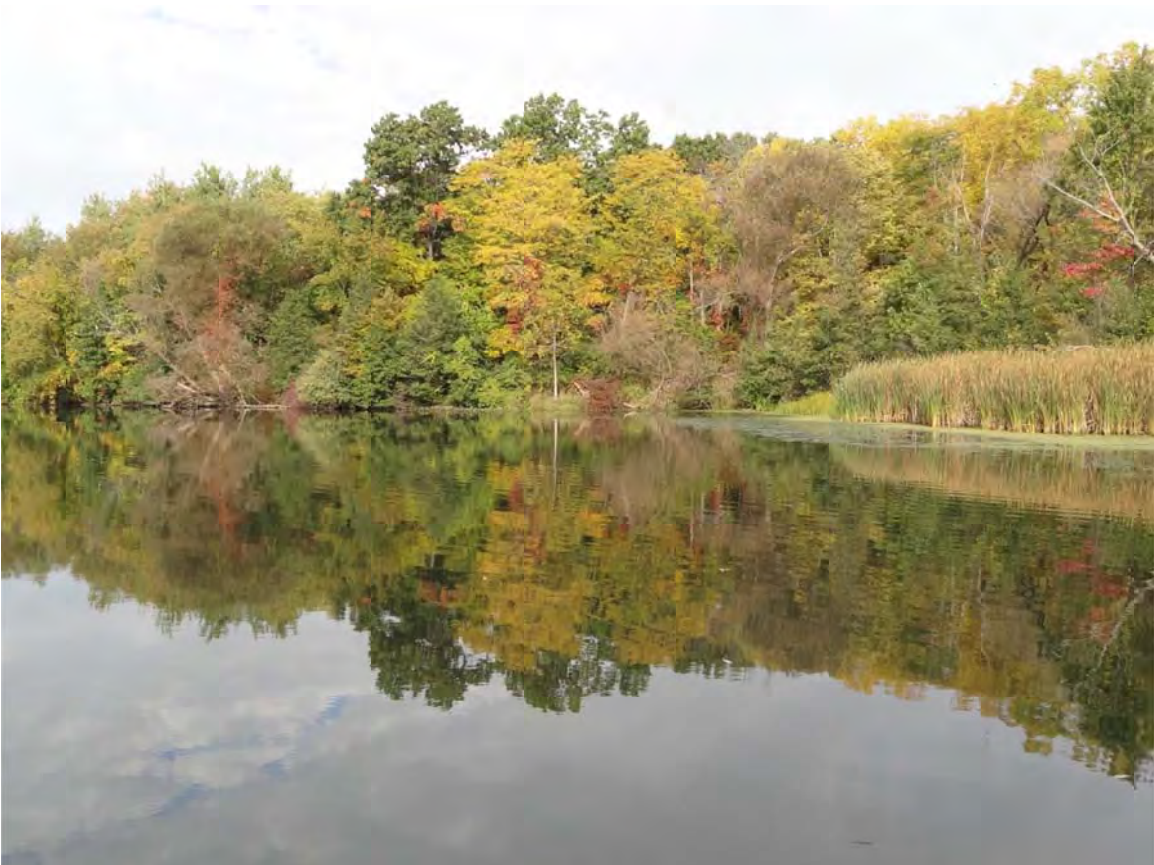
**18. North cove of Morrow Lake, no sheen or tar globules observed.**
